# Evaluation of Flexible Pavement Condition of Sultan Muhammad Kaharuddin Sumbawa Airport Runway Using Pavement Condition Index (PCI) Method

Nimas Arischa Singgih Purnamasari<sup>1</sup>, Agus Triyono<sup>2</sup>, Wiwid Suryono<sup>3\*</sup>, Siti Fatimah<sup>4</sup>

<sup>1,2,3,4</sup>Politeknik Penerbangan Surabaya, Jl. Jemur Andayani 1 No. 73, Surabaya, Indonesia

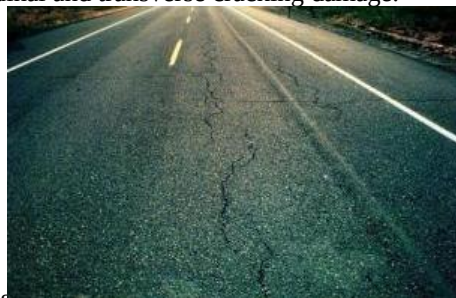
Longitudinal cracking occurs in line with the road axis while transverse cracking occurs perpendicular to the road axis. Individual cracks (not interconnected) that extend along the pavement. These cracks can be seen as one or several parallel cracks. The following are factors that cause damage:

Here is a picture of longitudinal and transverse cracking damage:

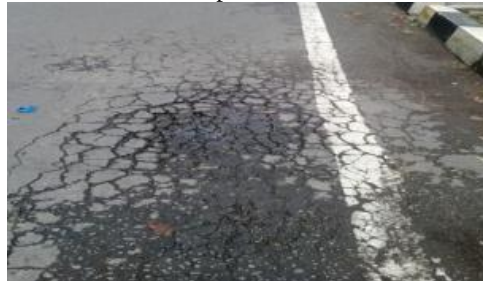
Crocodile cracks have two levels of damage, namely low damage with characteristics of a series of fine cracks connected without broken cracks, and medium damage, namely medium damage characterized by a series of cracks connected that form squares and small patterns. Severe (high) damage is characterized by cracks resembling cost skin where all the cracks are broken. If left untreated, this can cause roots and even holes. The Cause of Damage Factors is Swelling, or liquefaction, of hard soil that was initially intact will affect the base soil if groundwater is controlled, making the layer unable to withstand the pressure load given. As a result, there is a decrease in the road body, which then develops into fine cracks, which over time turn into cracks similar to crocodile skin. Here is a picture and table of crocodile skin damage.

**Figure 8.** Crocodile Skin Cracks

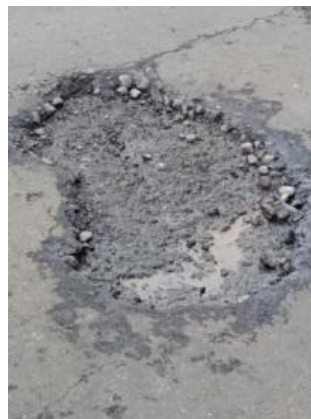
Grain release (raveling), namely the asphalt pavement surface, by continuously releasing aggregate particles from the edge of the pavement inward or from the pavement surface downward. This damage often occurs because the aggregate is easily absorbent, its compaction is not good because it is done during the rainy season, and the asphalt layer material mixture is insufficient. After the damaged layer is cleaned and dried, an additional layer can be applied on top of it to repair it. The following is a picture and table of the level of grain release damage:

**Figure 9.** Grain Release Damage

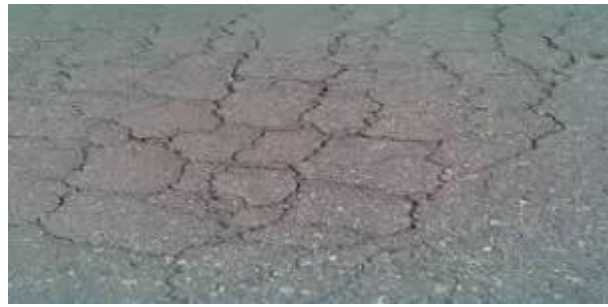
Block cracks usually occur in large asphalt areas that are rarely passed by traffic and consist of large blocks that are interconnected with side sizes between 0.20 and 3 meters. Crocodile skin cracks have a smaller shape and more sharp-angled fragments than this damage. Causes of damage include:

**Figure 10.** Block Crack Damage

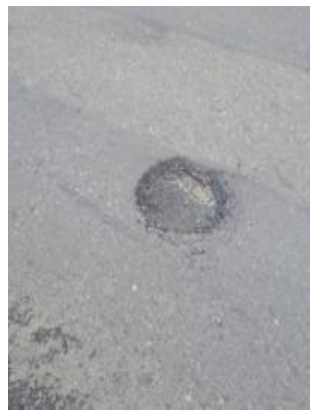
due to a poor mixture of surface layer materials, such as bowl-shaped holes that collect and absorb water into the surface layer, causing more severe road damage. This hole can happen

**Figure 11.** Hole Damage
