## Signs Facility Optimisation to Improve Services at El Tari Kupang International Airport Terminal

<sup>1,2,3</sup>Politeknik Penerbangan Surabaya, Jl. Jemur Andayani 1 No. 73, Surabaya, Indonesia

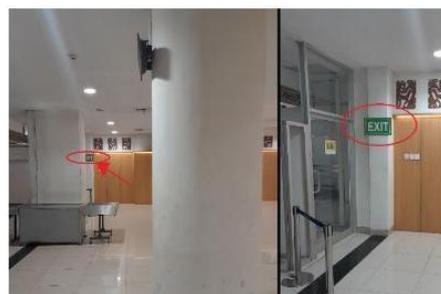
**Figure 1.** Exit sign that is covered by a pillar

In Figure 1. which shows signs or instructions (signs) that are still less than optimal. The placement of signs that are less strategic and less optimal which can make service users or airport officials experience accidents due to the lack of placement of signs, it creates confusion at the airport and harms service users and officers because there has been no further improvement effort.

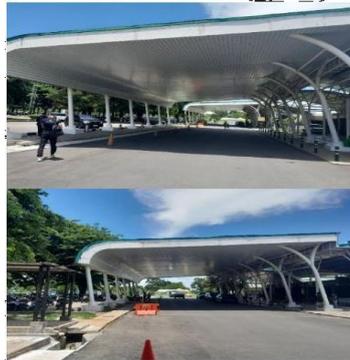
**Figure 2.** Absence of sign or clues (signs)

In Figure 2. shows the absence of sign facilities or instructions (signs) in the drop zone and pick up zone area which includes (only for dropping off passengers, no stopping for more than 3 minutes, and no leaving the vehicle). The drop zone is a place to drop off passengers who will enter the terminal and the pick up zone is a place that facilitates picking up passengers with a drive-thru system. This lack of standards and placement is appropriate based on Keputusan Menteri Perhubungan Nomor KM 22 Tahun 2005 establishing the Indonesian National Standard (SNI) on Signs at Airport Terminals as a Mandatory Standard in the standard and sign placement section, which will ensure that the quality and placement of signs will not be disturbed by advertisements or other signs in the vicinity.

Addition of signage at pick up zone and drop zone

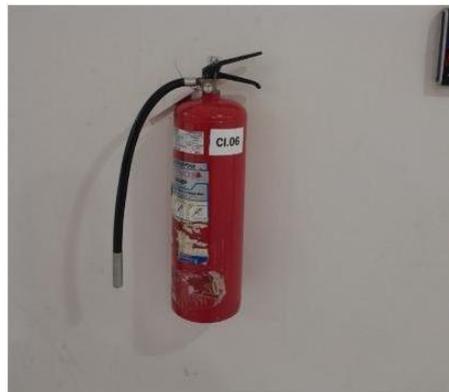
**Figure 3.** Light fire extinguisher sign (APAR)

In Figure 3. is a light fire extinguisher (APAR) located in the waiting room which has no sign or instructions on how to use it. This causes when in an emergency that requires a fire extinguisher, passengers who do not have experience or knowledge of how to use a light fire extinguisher (APAR) cannot help or handle the incident, so it will take time to wait for passengers or officers who have experience or knowledge of how to use a light fire extinguisher (APAR). This is contrary to Keputusan Menteri Perhubungan Nomor KM 22 Tahun 2005, which stipulates the Indonesian National Standard for Signs at Airport Terminals.

Addition of light fire extinguisher signs
2

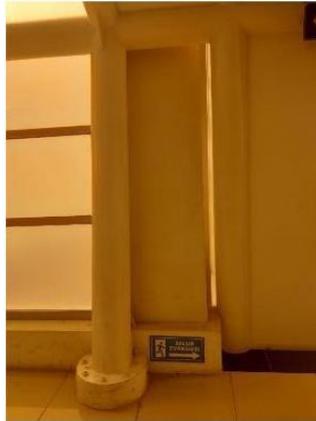
**Figure 4.** Placement of evacuation route signs or instructions

Figure 4 shows the evacuation route sign in the waiting room. It is not in accordance with Keputusan Menteri Perhubungan Nomor KM 22 Tahun 2005 on the Application of Indonesian National Standards Regarding Signs in Airport Terminals, which states that signs should be installed at a minimum height of 240 cm from the floor surface of the terminal building. They can be hung or affixed on one side to a section of wall or pole to customize the installation. The installation of signs will help passengers and staff know the evacuation route in the waiting room in case of an emergency.

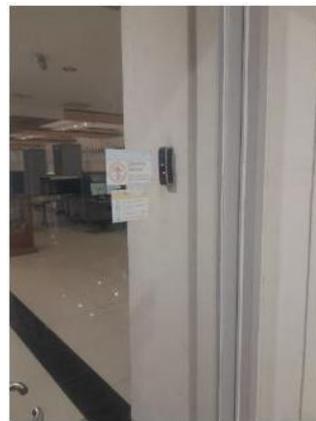
**Figure 5.** Fading sign of no entry except officers (staff) (Source: Researcher's Process)

In Figure 5 and Figure 6 are signs of instructions forbidden to enter except officers (staff) in front of the Aviation Security (Avsec) officer's room which already looks faded or becomes unclear, and Figure 4.6 is an exit sign at the check in counter which already looks damaged and faded. In accordance with the Keputusan Menteri Perhubungan Nomor KM 22 Tahun 2005 concerning the Application of Indonesian National Standards Regarding Signs at Airport Terminals that every sign or instruction (signs) at the airport terminal is required to be in optimal condition, namely the sign or instruction is clearly visible, there is no damage, strategic placement, and easy to read. With this, it can facilitate passengers and officers who are in the airport terminal.

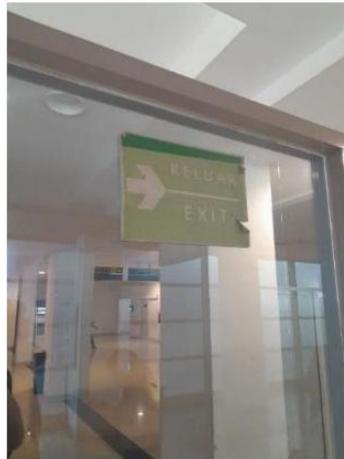
**Figure 6.** Damaged exit sign or instructions (Source: Researcher's Process)

In Figure 5 and Figure 6 are signs of instructions forbidden to enter except officers (staff) in front of the Aviation Security (Avsec) officer's room which already looks faded or becomes unclear, and Figure 4.6 is an exit sign at the check in counter which already looks damaged and faded. In accordance with the Keputusan Menteri Perhubungan Nomor KM 22 Tahun 2005 concerning the Application of Indonesian National Standards Regarding Signs at Airport Terminals that every sign or instruction (signs) at the airport terminal is required to be in optimal condition, namely the sign or instruction is clearly visible, there is no damage, strategic placement, and easy to read. With this, it can facilitate passengers and officers who are in the airport terminal.

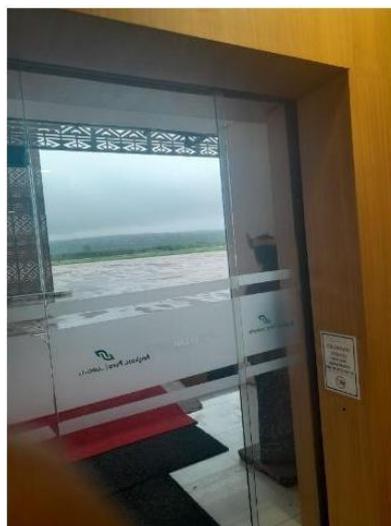
**Figure 7.** Placement of signs prohibiting hitting automatic door construction

Figure 7 shows a sign that says not to hit the automatic door. This is because it is not in accordance with the Keputusan Menteri Perhubungan Nomor KM 22 Tahun 2005 on the Application of Indonesian National Standards Regarding Signs in Airport Terminals, which states that signs should be installed at a minimum height of 240 cm from the floor surface of the terminal building. They can be hung or affixed one side to a section of wall or pole to customize the installation.

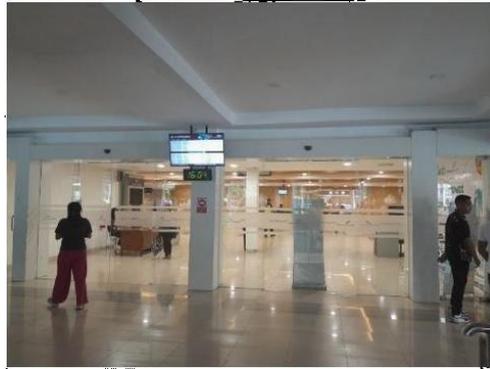
**Figure 8.** Placement of the no entry sign

Figure 8. No entry signs located outside the arrival area, their installation interferes with the flight information screen. This is because the Implementation of Standard Signs at Airport Terminals explains that every sign or instruction (sign) located at the airport terminal must not be obstructed by objects or objects so that the sign cannot be read by passengers or officers.

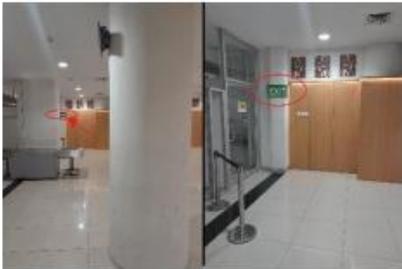
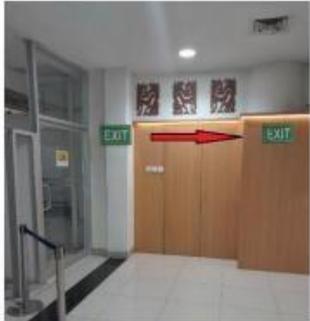
exit sign

Shifting of exit signs
3
